**DEPARTMENT OF TRANSPORTATION****DIVISION OF ENGINEERING SERVICES**

Contract #: 04-0120F4Cty: SF/ALA Rte: 80 PM: 13.2/13.9File #: 69.28**WELDING INSPECTION REPORT****Resident Engineer:**Pursell, Gary**Address:** 333 Burma Road**City:** Oakland, CA 94607**Report No:** WIR-003250**Date Inspected:** 15-Jul-2008**Project Name:** SAS Superstructure**OSM Arrival Time:** 630**Prime Contractor:** American Bridge/Fluor Enterprises, a JV**OSM Departure Time:** 1530**Contractor:** Zhenhua Port Machinery Company, Ltd (ZPMC), Changxing Island **Location:** Shanghai,China**CWI Name:** C.M. Chen**CWI Present:** Yes No**Inspected CWI report:** Yes No N/A**Rod Oven in Use:** Yes No N/A**Electrode to specification:** Yes No N/A**Weld Procedures Followed:** Yes No N/A**Qualified Welders:** Yes No N/A**Verified Joint Fit-up:** Yes No N/A**Approved Drawings:** Yes No N/A**Approved WPS:** Yes No N/A**Delayed / Cancelled:** Yes No N/A**Bridge No:** 34-0006**Component:** OBG**Summary of Items Observed:**

## WELDING INSPECTION REPORT

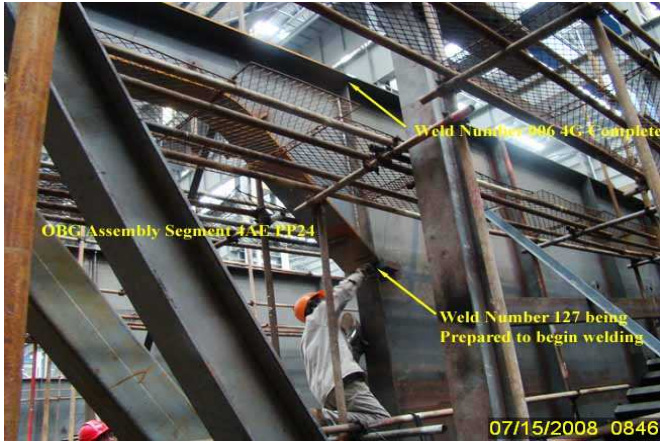
OBG Assembly Segment 4AE- Caltrans QA observed ZPMC depositing FCAW in the 4G position being deposited on CJP weld number 6 on Floor Beam FL 2-1 to FL 1-1 at location SSD 19 PP24 on the C5 side of Floor Beam. This weld is located on the top flange of the Floor Beam and designated weld number 006 and was welded by ZPMC welder Xu Li Guang. Caltrans QA observed ZPMC depositing FCAW in the 4G position being deposited on CJP weld number 127, on Floor Beam FL 2-1 to FL 1-1 at location SSD 19 PP24 on the C5 side of

Floor Beam. This weld is located on the lower flange of the Floor Beams and was also welded by ZPMC welder Xu Li Guang. Both welds utilized the following Welding Procedure Specification WPS-B-T-2231-B-U2-F-1. This QA inspector witnessed ZPMC's QC inspectors monitoring and recording weld parameters for the above mention items. See photograph for additional information and/or weld locations.
